Division of
Oil, Gas & Mining

SUBJECT: Site Inspection, American Gilsonite, Bonanza Operations,
M/047/010, Uintah County, Utah

Date of Inspection: July 7, 2004
Time of Inspection: About 12:30 to 6:45 p.m.
Conditions: Partly to mostly cloudy with a few showers, 80's
Participants: Clay Taylor, American Gilsonite; Paul Baker, DOGM

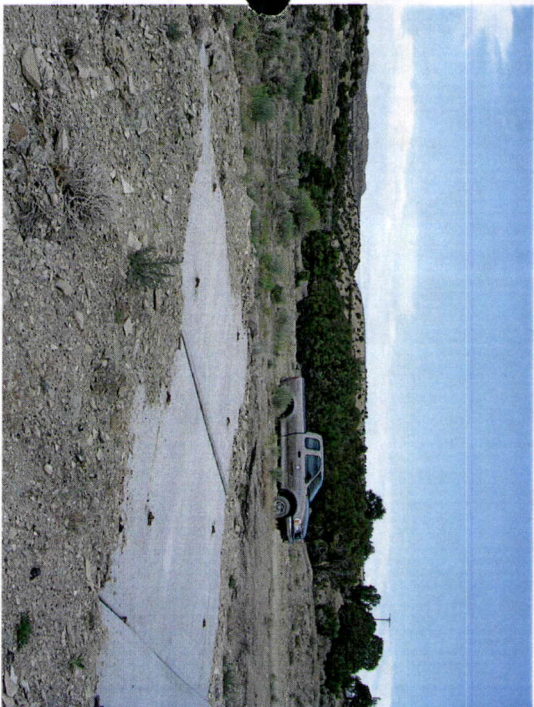
Photo 1. R-2.

Site	Comments
R-2	Slabs placed over concrete footings (Photo 1). Natural invasion of rabbitbrush and snakeweed. Gap between two of the slabs (Photo 18), and some evidence of piping or rodent burrows (Photo 19).
R-4	Polyurethane foam used to seal the openings. No evidence of failure. Almost no signs of surface disturbance (Photo 3). A lot of cheatgrass in some areas (Photo 4), but there is natural invasion of native species (Photos 2 and 3).
H-2	Natural invasion of snakeweed and rabbitbrush but still a lot of halogeton. Surface is rocky. Shaft sealed with polyurethane foam. No evidence of failure. Photos 5 and 6.
H-10	Openings sealed with polyurethane foam with no evidence of failure. Vegetation on the access road is coming along nicely with a fair amount also

Site R-2 could be released but for a few minor problems. The gap between the concrete slabs should be filled, and the operator should fill the hole shown in Photo 19 and pile dirt so water would drain away from the cap. In addition, the Division has some concerns about the slabs, but these concerns should not stop release. Chains were incorporated with the concrete for lifting the slabs, and as these chains rust, the concrete may deteriorate. I have not seen documentation that reinforcing steel was used in these slabs, but, assuming it was, it was probably not coated. For these reasons, even when the site is released, it should be periodically inspected.

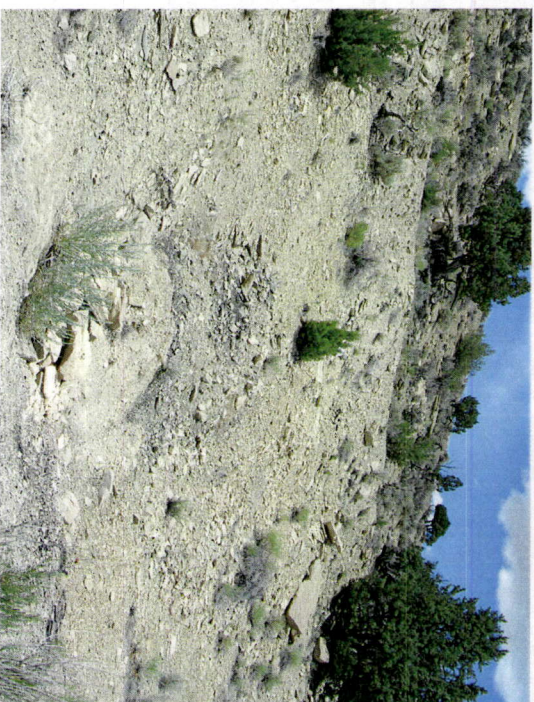
I did not see any problems with the polyurethane foam used at sites R-4, H-2, and H-10. The Division originally approved use of polyurethane foam as an experimental practice and said it anticipated a minimum period of five years

Photo 3. R-4. The area near the bottom center of this photo was filled with polyurethane foam then covered.

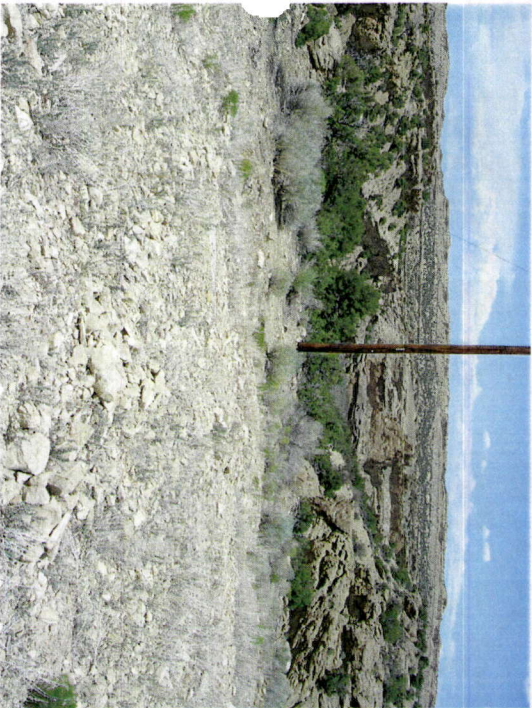
Photo 5. H-2. The ground is rocky, and there is some natural invasion.

The operator also needs to seed these sites in the first fall after they are reclaimed. At the Harrison and Rainbow sites, there is some natural invasion of native species, but these sites should have been seeded. For this very dry environment, I suggest a seed mix that includes some aggressive non-native grasses.

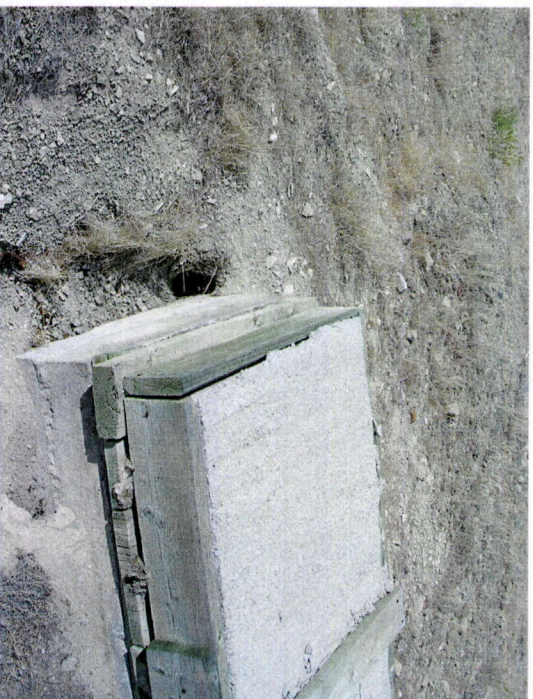
growing at the mine site (Photo 7). Lots of winterfat at the mine site.
WH-12	Attachment A of the Reclamation Contract shows this area having equipment, but it has been removed. Did not take photos.
LE-20	Footer topped with treated lumber on which the cap was poured (Photo 8). Some burrows around the footer, but they don't appear to extend into the shaft. Vegetation is mostly weeds.
LE-19	Cap poured on existing foundation (Photo 9). Vegetation similar to LE-20.
LE-18 and LE-17	Photos 10 and 11. The disturbed areas are smaller than for LE-19.
LE-16	Did not take a picture. There is no cap yet. Vegetation in the disturbed area is mostly weeds; the area needs to be seeded.
LE-10	There are two caps (Photos 12 and 13). One is a "monopour," and the other is a footer with slabs over the top.
B-42	No cap yet. The hoist house is still at the site (Photo 14) as is some other equipment.
B-40	Another "monopour" cap (Photo 15). The site needs to be cleaned up and seeded.

Photo 8. LE-20. These rodent burrows do not appear to go into the shaft.

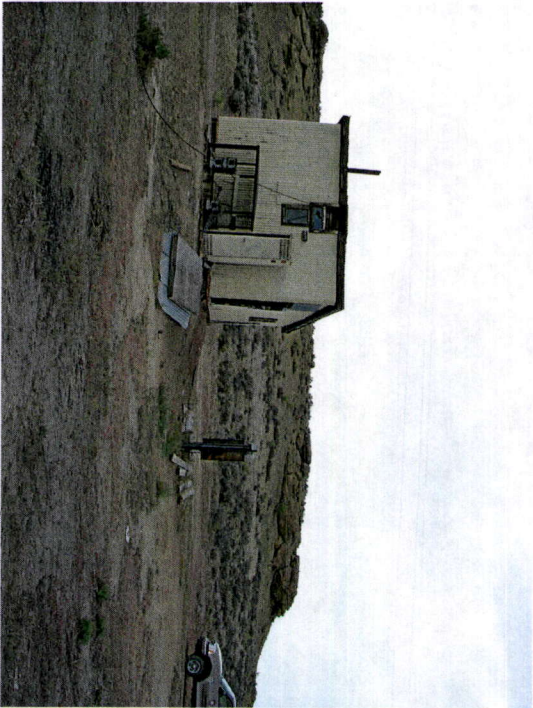
Photo 14. B-42. The hoist house. There is some other equipment still at this site.

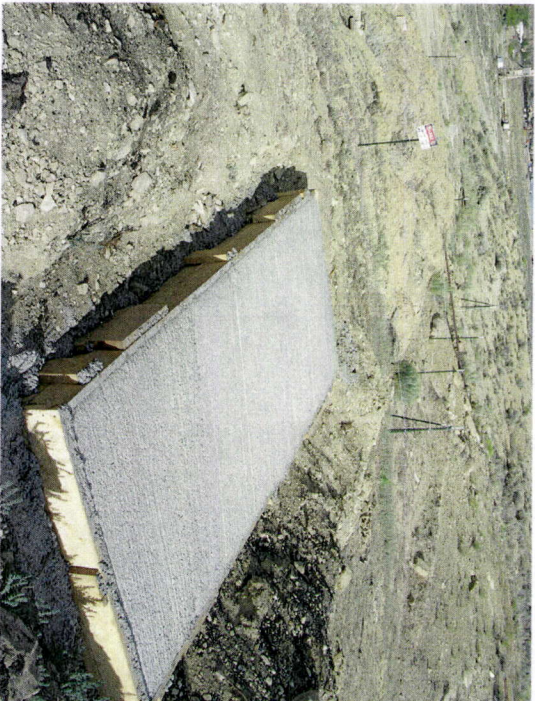
Photo 16. I-30.

I-30	The equipment is gone, but the operator may come back again (Photo 16).
I-16	This site needs to be capped and the area seeded. The equipment has been removed. Did not take a picture.
B-28	Photos 17 and 20. Equipment is gone, and the site is being reclaimed. This area was re-impacted by mining.

Attachment A of the reclamation contract needs to be updated to show which sites have been released, to include new ones that have been added, to show the current status of activity, and to show current land ownership status. Site I-30 is shown on Attachment A as being State land, but the area is now managed by the Bureau of Land Management and covered under their bond. Equipment has been removed from WH-12, but Attachment A indicates the equipment is still there.

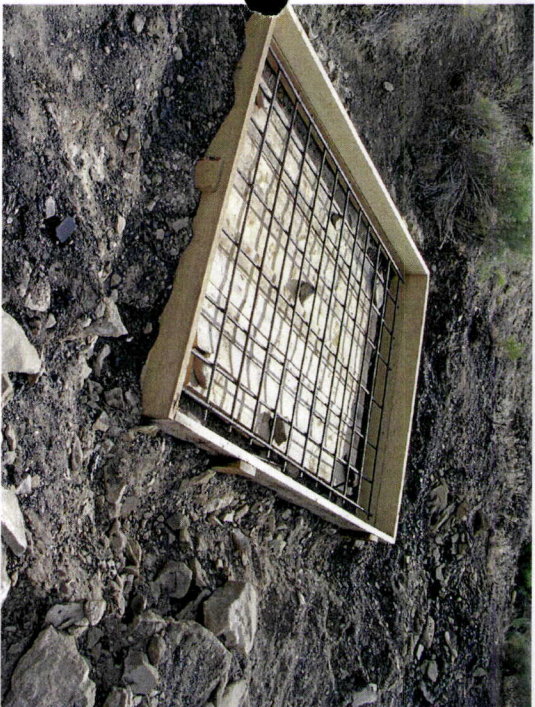
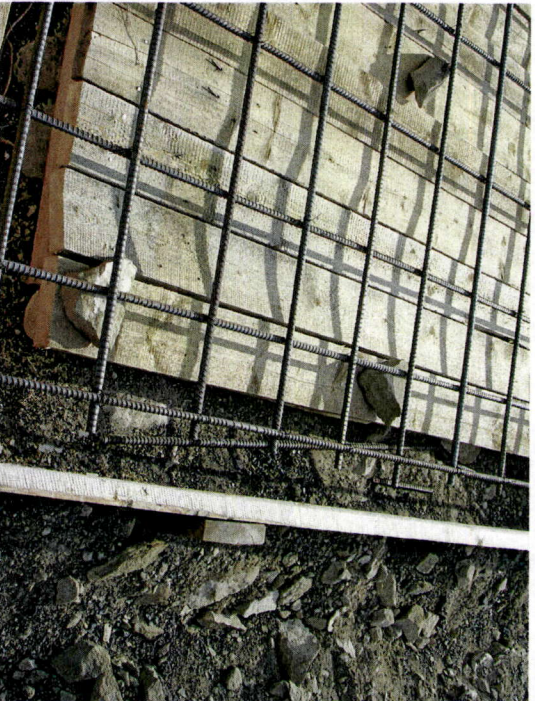
Photo 17. B-28.

Photo 20. Another view of B-28.

Looking at the pictures of B-28 (Photos 17 and 20), it is not clear whether this site has been excavated to bedrock. Before pouring concrete, the operator should be sure the footing goes on bedrock.

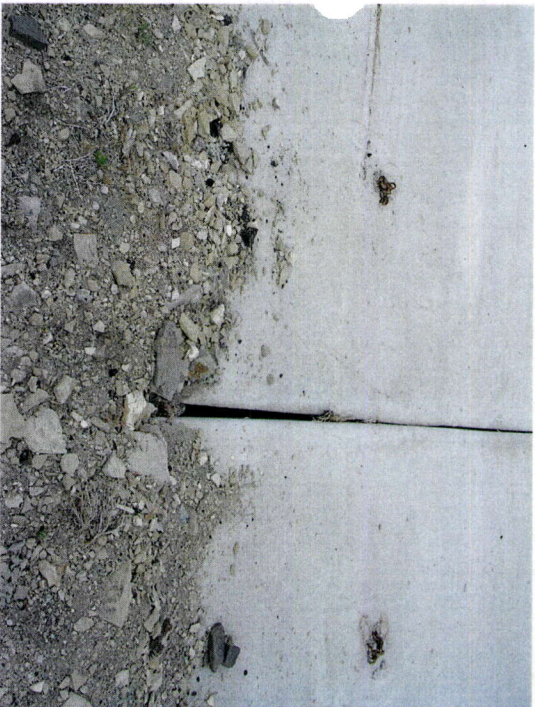
Photo 18. Gap between two of the slabs at R-2.

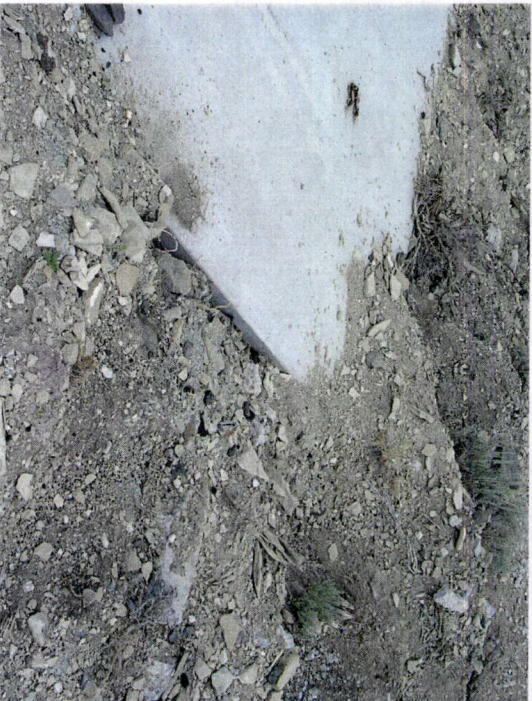
Photo 19. The cap at R-2.
